Facility Audit Report

2016 Facility Audit Report Spooner Area School District

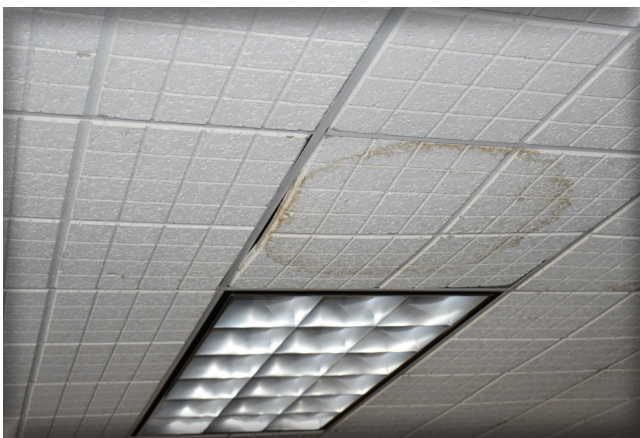
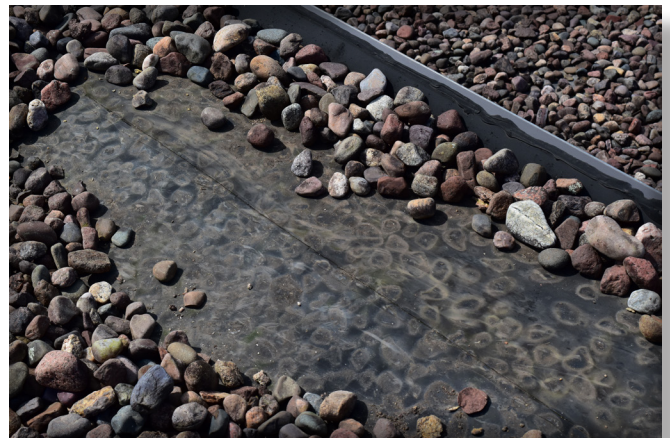
The roofing at Spooner Elementary School is the original ballasted rubber roof. At approximately 30 years age, it has been well maintained and has surpassed the predicted useful life of the product. During the time of the audit, it was apparent there have been multiple leaks where water has damaged ceiling tiles and pooled on the floor. The roof was observed to have seams that were separating and will continue to form new leaks due to the degrading of the material until the roof is replaced.

There were no obvious signs of microbiological growth or structural issues that have been caused by water entering the building, but those are a real possibility with the number and size of the leaks that were observed.

Option	Estimated Building Costs
Replace roof with same type of rubber roof with rocks over the top (ballast).	\$315,000
Convert roof to a fully-adhered roof.	\$630,000

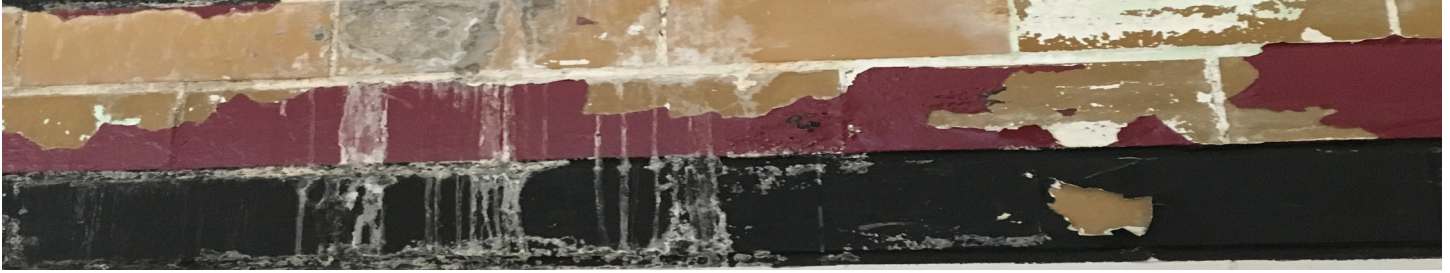
MIDDLE SCHOOL GYM

The exterior of the old gym at the Spooner Middle School is brick covered in stucco. It was evident at the time of the audit that the brick was in poor condition due to moisture issues. The bricks on the outside were spalling (flaking) and there was efflorescence (white patches caused by the migration of salt through bricks). The brick on the inside and doorways were showing similar serious signs of degradation due to moisture.

The moisture and safety issues need to be addressed at the middle school gym. There are several options ranging from repair to demolition. Determining which option is best will require further study and conversations with the District to identify the needs of the school.

Option	Estimated Building Costs
Repair the existing structure - The visible brick inside and outside along with the doorways is not an overly daunting task, but analyzing the interior support members in the wall is. At minimum, a structural engineer should be brought in to study the condition of the load bearing structure and give a recommendation.	Current estimate is \$500,000 to fix existing walls. Additional costs may be incurred to repair roof and ceiling. This cost is dependent on results of structural engineering evaluation.
Tear the building down - This option is not overly cost prohibitive and will eliminate any future cost and safety concerns associated with the old gym. This will eliminate a space currently being utilized by the school, and some expense would be incurred to finish the spot where the gym stood to level ground.	\$250,000
Demolish the existing gym and rebuild a new space - A few possibilities include an auditorium, a new office/entryway, and a new area for modern science and technology classrooms.	\$2-3 million

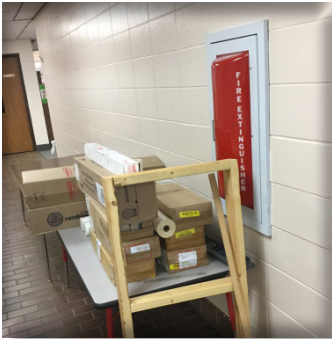
During the time of the audit it was noted that there was a fire extinguisher that was blocked. As the picture shows, it would be difficult to get to the fire extinguisher in the event of an emergency. Regular inspections should be made to ensure that all fire safety equipment and doorways are free and clear of obstructions.

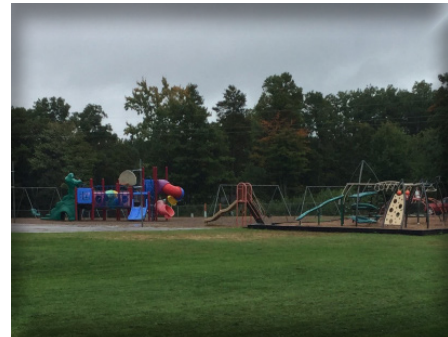
PLAYGROUND

The playground equipment itself appears to be in good condition, but the amount of sand under the equipment is inadequate. The amount of sand under the equipment should be more than 10" deep to minimize the risk of injury.

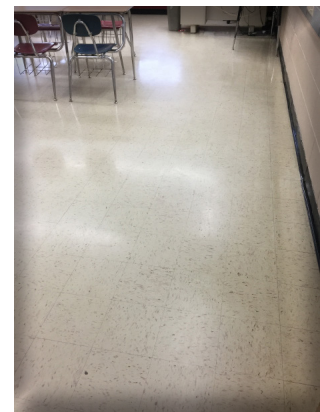
ASBESTOS

Facilities that are as old as the Spooner Middle School typically have a large amount of asbestos containing materials in them from the time of construction or from renovations through the years. A full asbestos audit wasn't done at this time, but it was noted that there were a few areas with materials that are known to contain asbestos. One such material is vinyl tile flooring. The Spooner Middle School has tile flooring that is still intact, and therefore isn't an immediate risk, but has the potential to become a hazard if it starts to chip or crack. The flooring, along with any other materials in the building that are known to contain asbestos, should be abated before any potential exposure.

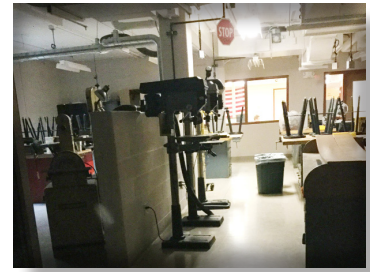
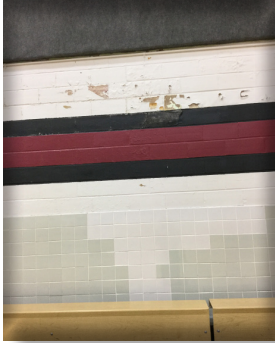
SHOP - NO BOLTS

It was observed during a walk-through of the shop areas at the middle school that the drill presses were not bolted down. There is a safety hazard when tall, heavy equipment such as drill presses are not bolted down to the floor. If the presses are knocked over, serious injury could result.

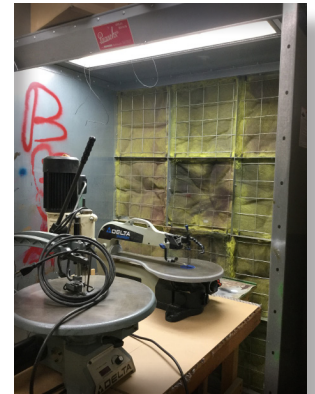
VENTILATION

The ventilation in the shop areas was not tested at the time of the audit, but needs to be evaluated to make sure that no students and staff are not being exposed to harmful chemicals. Any areas where welding, machining, painting, finishing work or other processes that could generate hazardous fumes take place need to be evaluated.

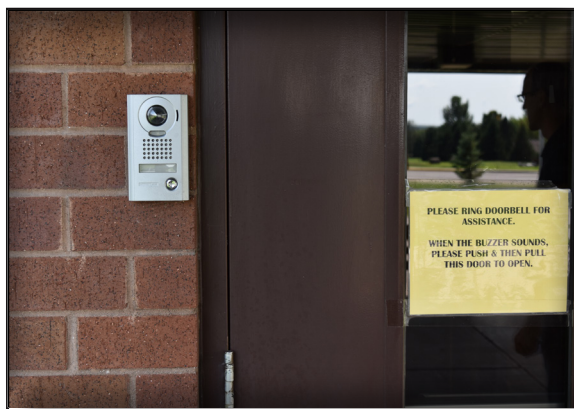
◀ The front doors at the elementary school don't always close completely due to 30 years of wear and tear. Doors that do not close and lock override any security measure that the buzzer and camera system provide. Until this is fixed, anyone could walk up to the school and enter without authorization. Due to the age and condition of the doors, the recommendation is to replace the doors and make any necessary repairs to the handicap access equipment to ensure reliable function.

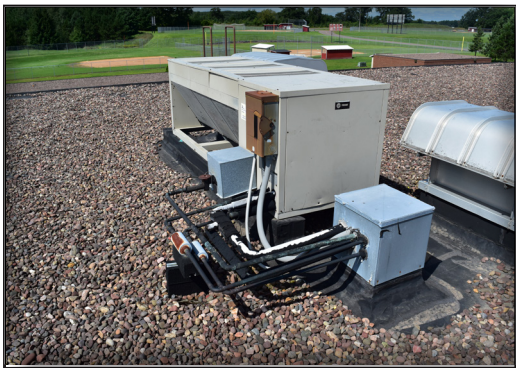
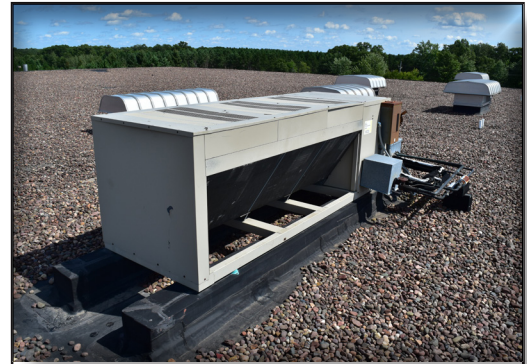
Replace air conditioning units

▲ Repairs were made to the air conditioning unit at the elementary school this summer. Due to its age and exposure to the elements, it will likely continue to need repairs and will be unreliable. The air conditioning unit at the elementary school should be replaced.

Air conditioning units have seen huge efficiency gains over the last 30 years as well. A new unit would help to pay itself back in utility savings over the years. ▶

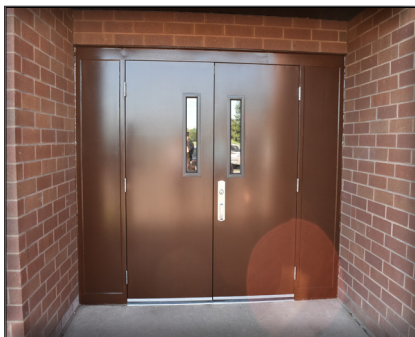
Replace exterior doors

◀ Even though these are commercial doors and have been well maintained, when they have been used for 30 years, they will have issues. The doors that are original should be scheduled for replacement.

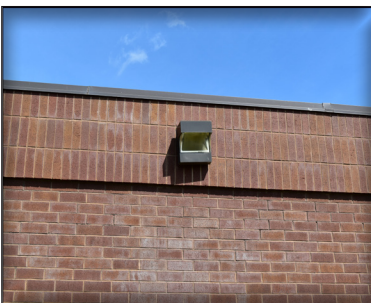
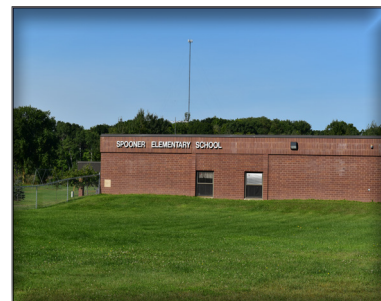
**Upgrade exterior lighting**

◀ The exterior lighting is obsolete and low efficiency. The payback on utility costs and maintenance savings of new LED lighting is very favorable. The exterior lighting should be upgraded before any major repairs or maintenance is performed on the existing fixtures. ▶

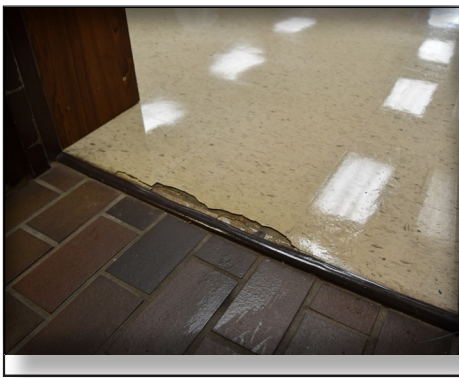
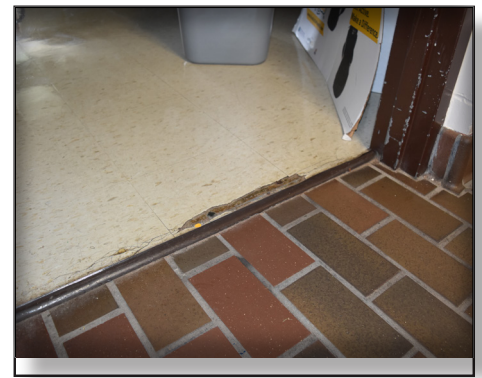
◀ Wherever there is a transition for the flooring, such as the transition from a doorway to a classroom or from carpeting to vinyl tile in the middle of the classroom, there are issues with the flooring being in poor condition. The vinyl tile throughout the building has been damaged or is peeling because of years of use. The carpet in the classrooms has also surpassed its predicted useful life and needs replacement to address areas that have trip hazards or are excessively worn. ▶

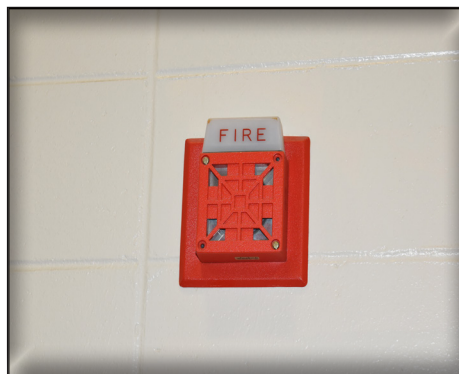
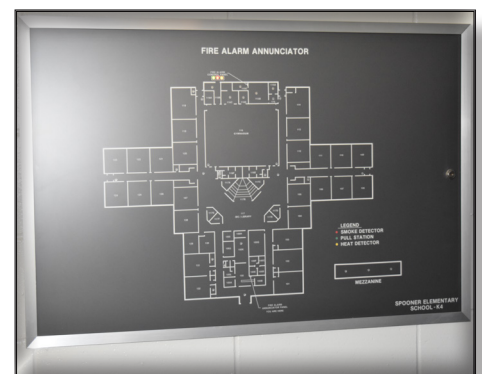
◀ Not only is this system critical to safety, but can also cause disruption and anxiety if alarms are tripped due to equipment malfunction. To guarantee a high level of reliability and reduce the annual cost of maintaining the fire alarm system, the system should be updated. Any obsolete parts and components should be replaced and updated. ▶

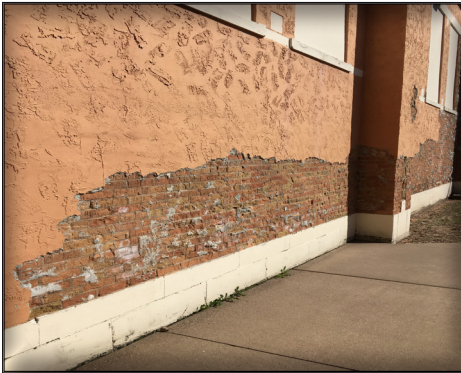
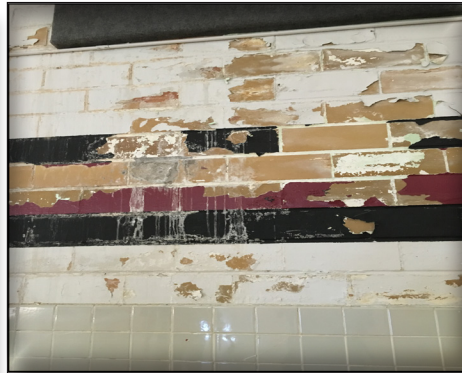
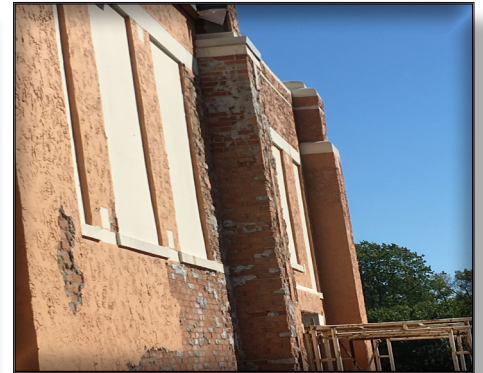
▲ The moisture and safety issues need to be addressed at the middle school gym. There are several options ranging from repair to demolition. Determining which option is best will require further study and conversations with the school district to identify any needs at the school.

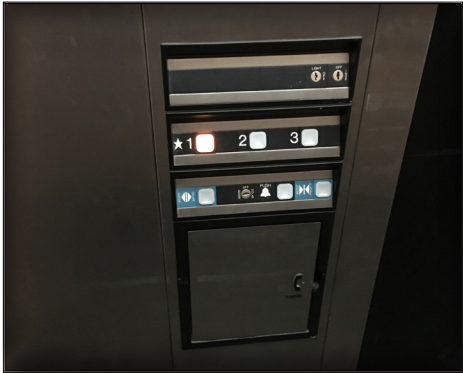
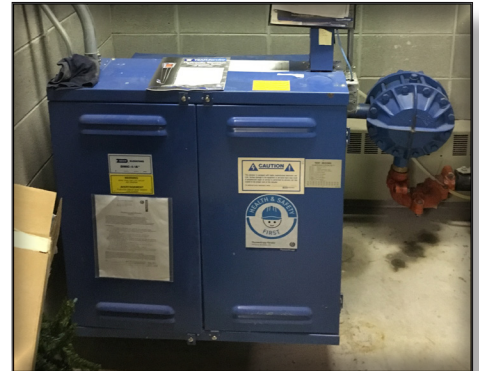
◀ Due to its age, there aren't any replacement parts available for the elevator. This is a major concern, because if the controls malfunction, the elevator will be out of service for an extended amount of time. ▶

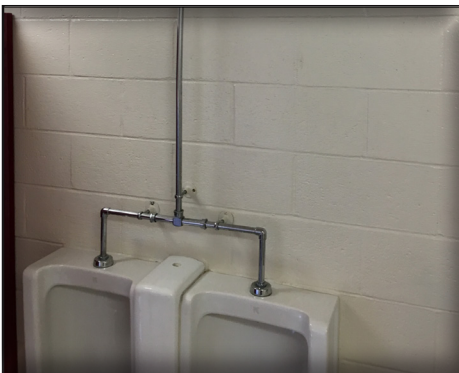
▲ The urinals in a few of the bathrooms are the old "fill and flush" style that continuously run water anytime the lights are on. This type of system uses much more water than newer systems. They should have motion activated valves installed.

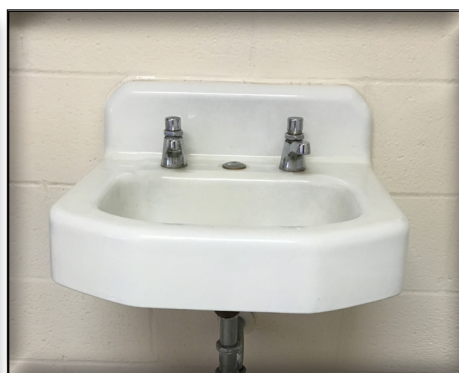
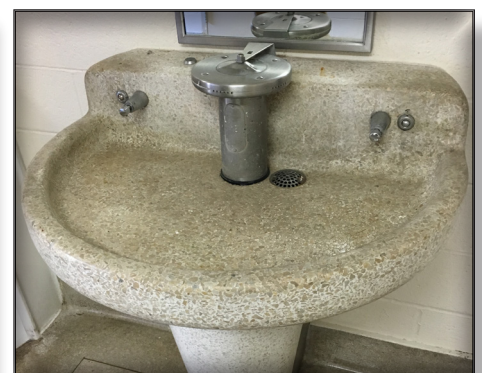
▲ The hand wash stations and the oldest sinks need to be replaced. They are difficult to adjust and parts are becoming obsolete.

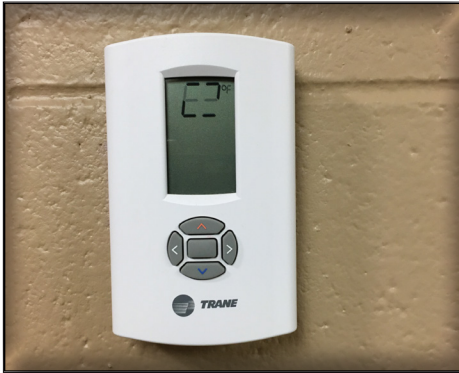
Replace thermostat

◀ The thermostat for the office air conditioning has a malfunctioning display and cannot be programmed. The thermostat needs to be replaced.

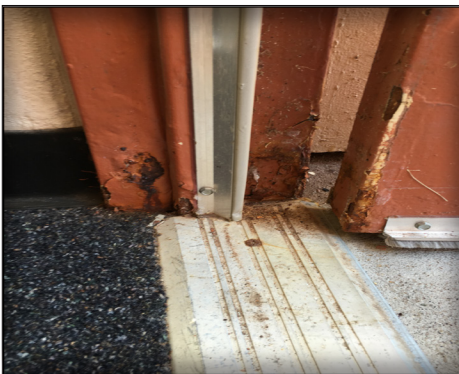
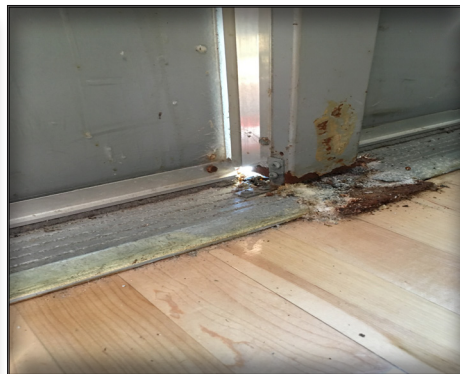
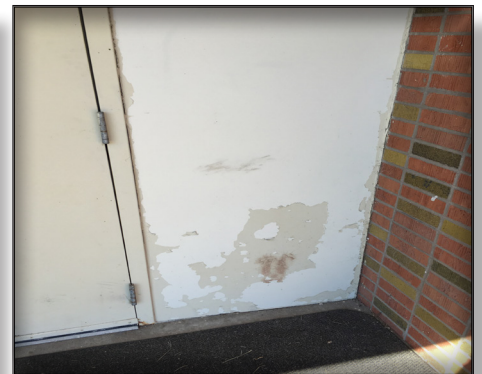
▲ Several sets of exterior doors have deteriorated due to age and exposure to salt that is used for de-icing. Doors that are in poor condition are difficult to close at times and could pose a security risk.

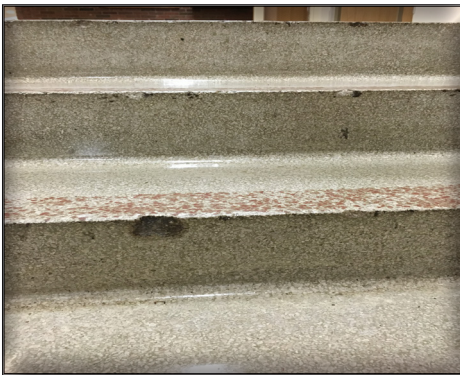
The concrete steps and sidewalks surrounding the building need to have cracks repaired, uneven pavement leveled, and curbs should be painted yellow to let people know that there is a step according to applicable codes to avoid trip hazards. ▶

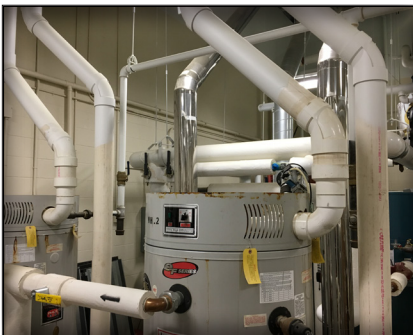
Replace domestic water heaters

◀ The existing domestic water heaters need to be repaired or replaced. Based on the reliability of the existing water heaters, the more cost efficient option is most likely replacement.

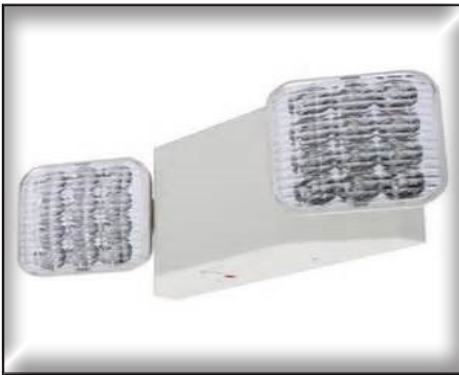
Replace emergency lighting

◀ The existing emergency lights at the high school should be replaced with fixtures that require less maintenance and are more reliable. New fixtures with LED lights and lithium batteries last much longer between maintenance needs than old fixtures.

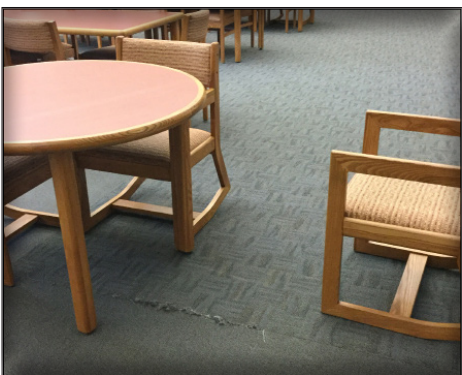
◀ The carpeting in the building is the most urgent flooring need. There are areas in the library and in the office where the carpet is separating at the seams. The carpeting needs to be scheduled for replacement to reduce the safety issues associated with trip hazards.
